# VIBRATION TESTING OF MINIATURE S-BEAM (LSB200) & MINIATURE BEAM LOAD CELL (LSM400)

FUTEK ENGINEERING TEAM  
James V. Meiselbach, Mechanical Engineer

## Executive Summary

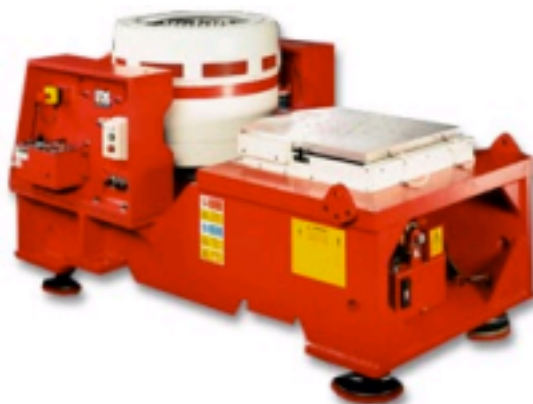
Figure 2, Low Pressure slip table, capable of vibration testing in the x, y, and z-axis.

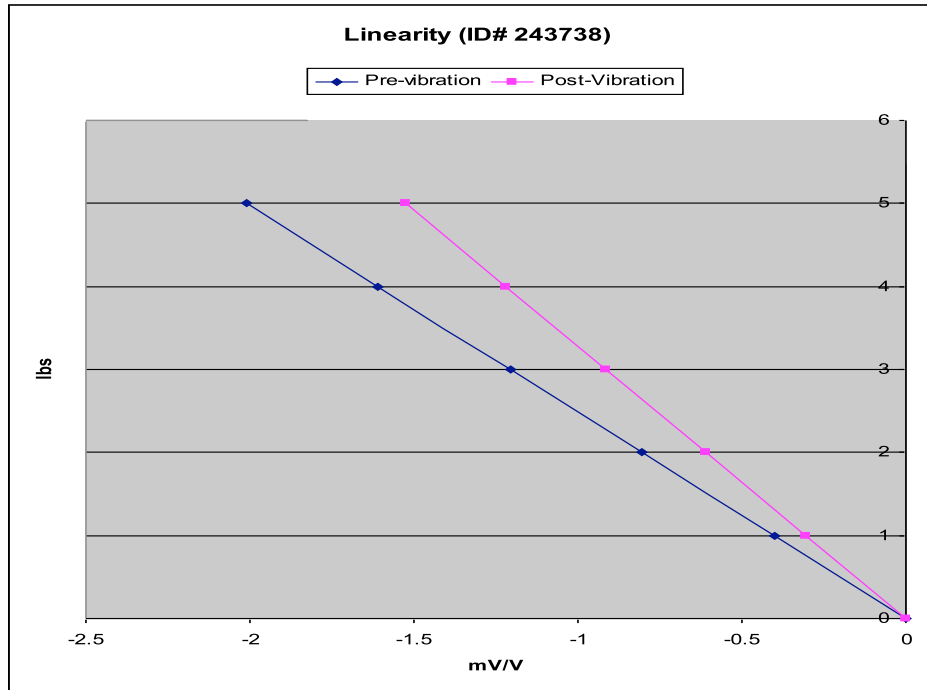
Figure 9, Linear response curve for LSB200 (ID# 243738), note the shift due to 111Ω span resistor.

Span resistor calculation:

$$\left( \frac{(R_B \times V_o) - (V_{spo} \times R_B)}{V_{spo}} \right) = R_{span}$$

$$\left( \frac{(351.71\Omega \times 2.0105 \text{ mV/V}) - (1.5274 \text{ mV/V} \times 351.71\Omega)}{1.5274 \text{ mV/V}} \right) = 111.2420\Omega$$

Pre-vibration rated output calculation with 111Ω resistor:

$$\frac{352\Omega}{(352\Omega + 111\Omega)} \times 2.0105 \text{ mV/V} = 1.5285 \text{ mV/V}$$

Output shift error:

$$\frac{(.5285 \text{ mV/V} - 1.5274 \text{ mV/V})}{1.5274 \text{ mV/V}} \times 100 = 0.072\%$$

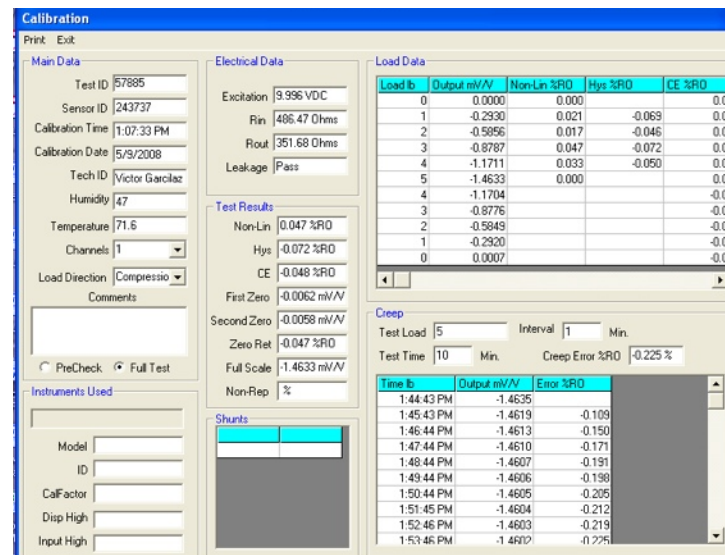
Figure 12, Sensor ID: 243737, LSB200, Calibration results performed on 5/9/2008, after vibration testing.

% Zero shift calculation:

$$\left( \frac{0.0142 - 0.0062}{1.4633} \right) \times 100 = 0.5467\%$$

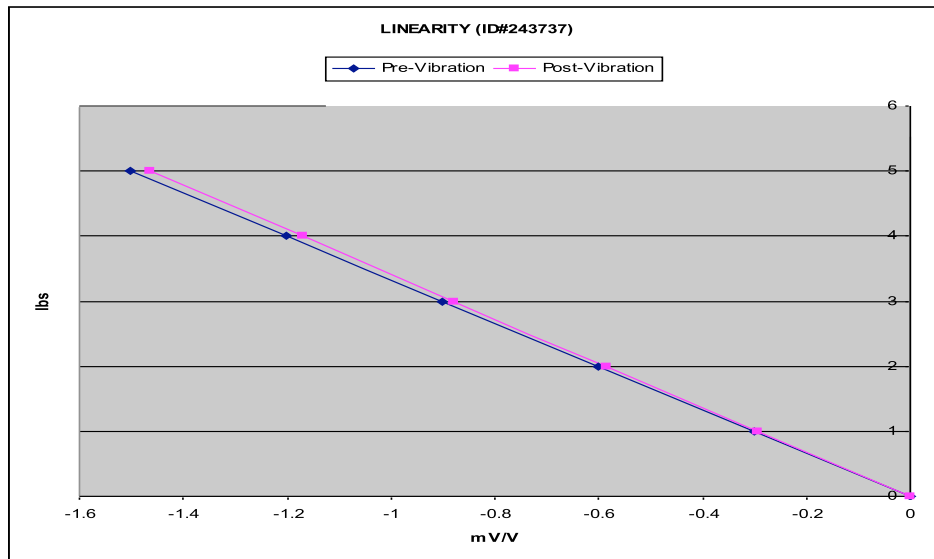
Figure 13, Linear response curve for ID# 243737; note, span resistor installed prior to pre-vibration testing.

Span resistor calculation:

$$\left( \frac{(471.57\Omega \times 1.5031 \text{ mV/V}) - (1.4633 \text{ mV/V} \times 471.57\Omega)}{1.4633 \text{ mV/V}} \right) = 12.8213\Omega \approx 13\Omega$$

Pre-vibration rated output calculation with 111Ω resistor:

$$\frac{471.57\Omega}{(471.57\Omega + 13\Omega)} \times 1.5031 \text{ mV/V} = 1.4677 \text{ mV/V}$$

Output shift error:

$$\frac{(1.5628 \text{ mV/V} - 1.4633 \text{ mV/V})}{1.4633 \text{ mV/V}} \times 100 = 0.034\%$$

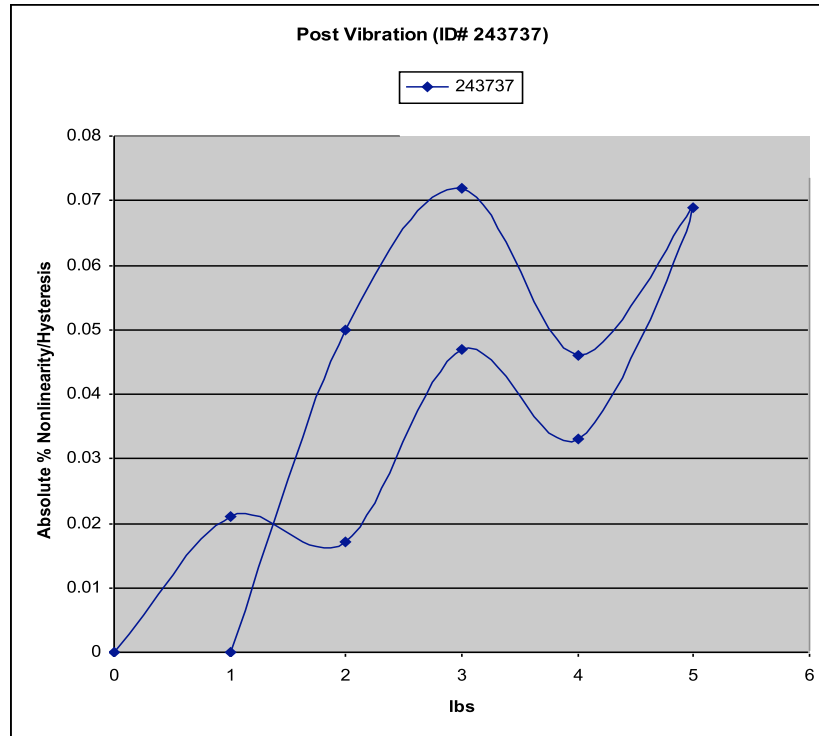
Figure 14, Post vibration Absolute % Nonlinearity/Hysteresis.

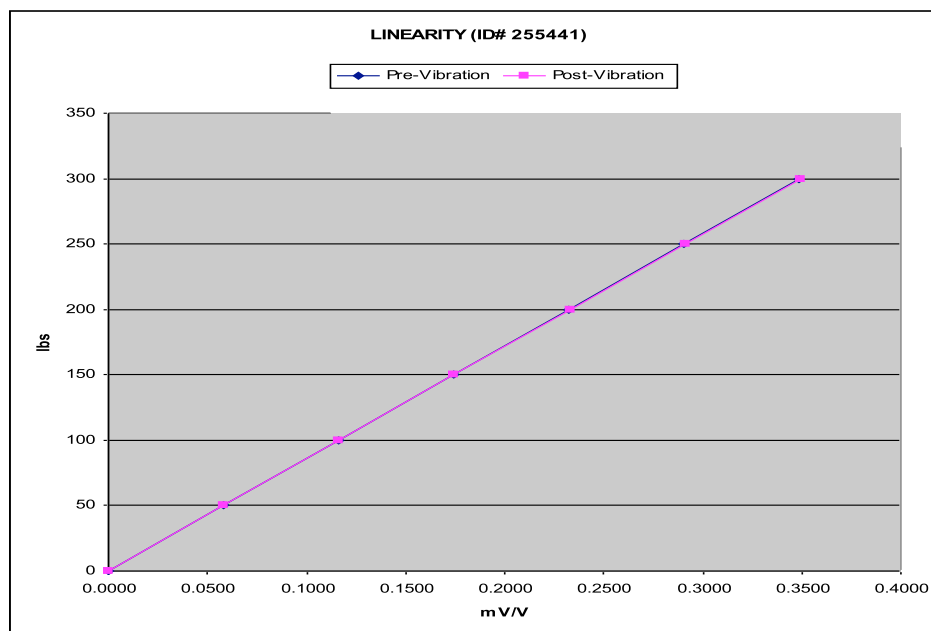
Figure 17, Linearity response curve for ID# 255441.

Output shift error:

$$\frac{(0.3489 \text{ mV/V} - 0.3492 \text{ mV/V})}{0.3492 \text{ mV/V}} \times 100 = 0.086\%$$

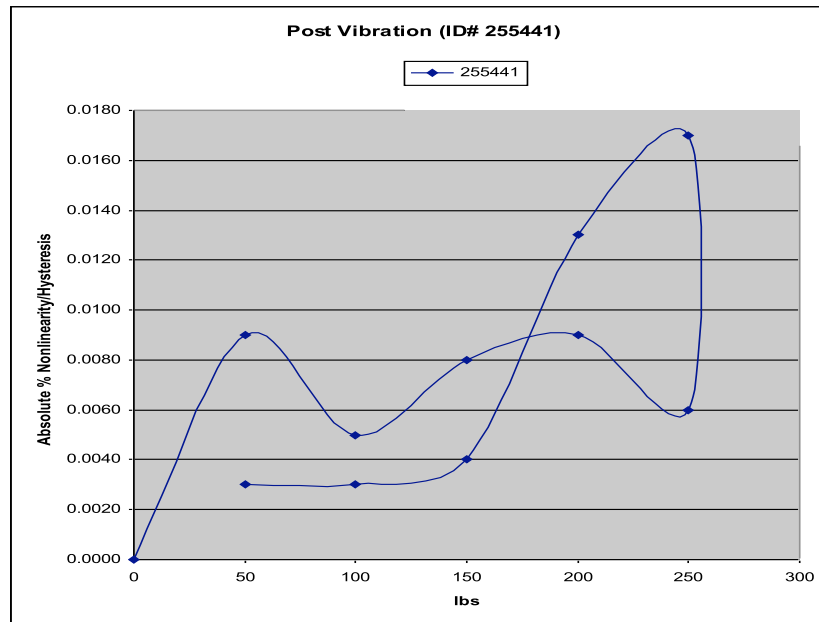
Figure 18, Post vibration Absolute % Nonlinearity/Hysteresis.

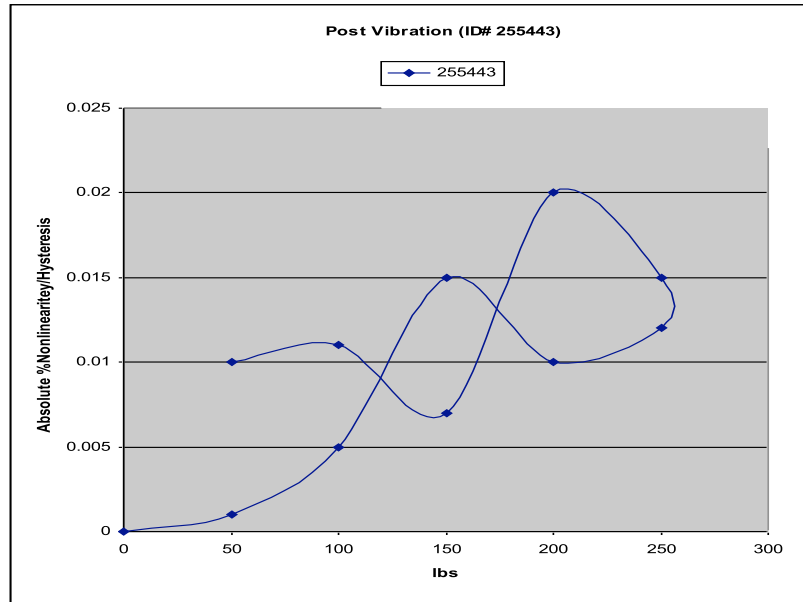
Figure 22, Post vibration Absolute % Nonlinearity/Hysteresis.

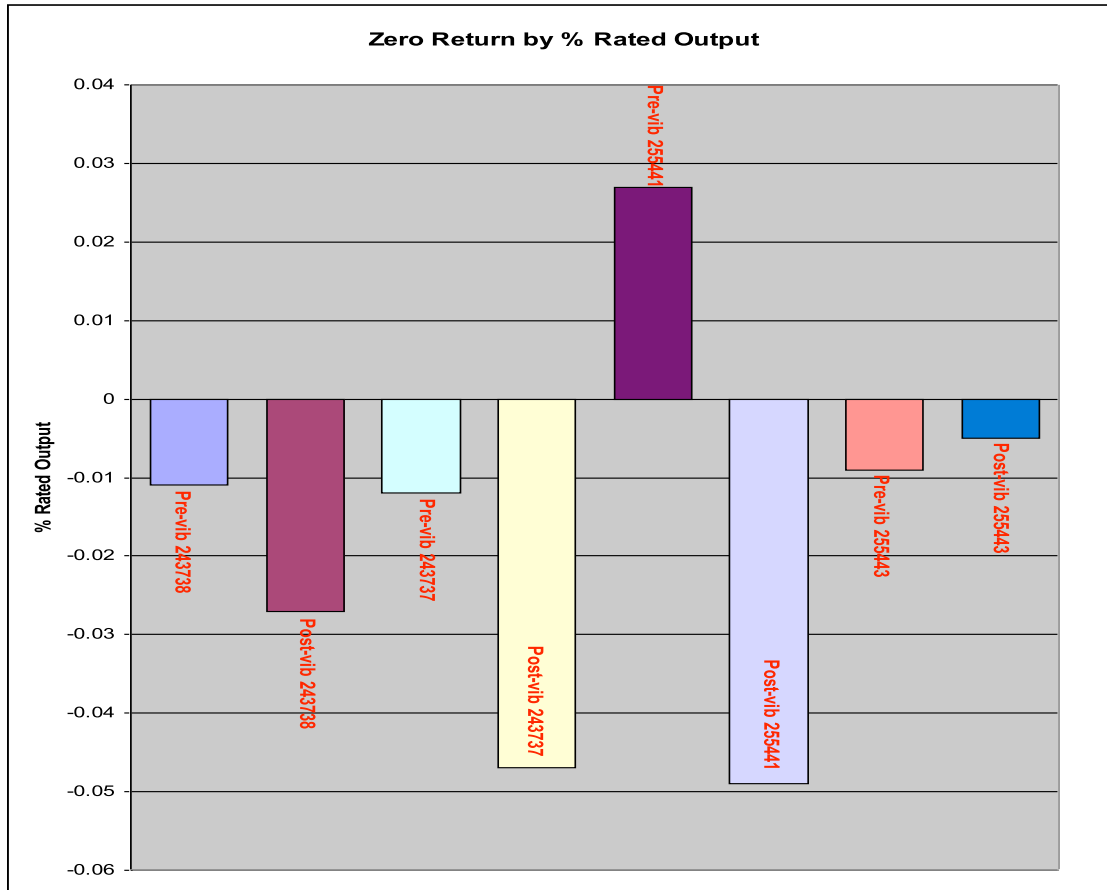
Figure 23, Zero return by percent of rated output.

Of the four FUTEK units tested, none failed during testing, came loose, or had any interruption in signal. Data capture rate was 1/sec as per application software. The plots generated are for comparison to a standard not provided by the client. To better show and validate the robust nature of the units, before and after calibration results were generated which show virtually no change in calibration output signal, nonlinearity, or zero balance, see figure 5 through 12. Further examination of the internal sections show no visible damage, loose or potential disconnects. All adhesives used in the fabrication of the units showed no sign of failure either. Cover screws installed with Loctite 262 held and showed no sign of fatigue or failure. The adapters installed on the LSB200 with Loctite 242 showed no sign of failure either. Cable connections and cable strain relief's were examined and showed no sign of fatigue or potential for failure. It is clear that these two sets of units, LSB200 and LSM400, survived this series of vibration tests. Therefore, it is reasonable to expect these units to survive an environment which could potentially expose them to a vibration Spectral Density of  $0.01\text{g}^2/\text{Hz}$ .
